The existing bridges in the Downtown Reno Reach have not been evaluated in detail for stability (e.g., pier scour, over topping, uplift on the deck) for the with-project conditions with Risk and Uncertainty (R&U) increments. The purpose of this memorandum is to summarize previous evaluations of the Downtown Reno bridges and to recommend any additional analyses. The bridges discussed in this report include:

Flood Damage Reduction Alternatives Report Addressing Downtown Reno Bridges, Truckee Meadows, Nevada. U.S. Army Corps of Engineers. June 2002.

CHAPTER II EVALUATIONS OF BRIDGES UNDER EXISTING CONDITIONS

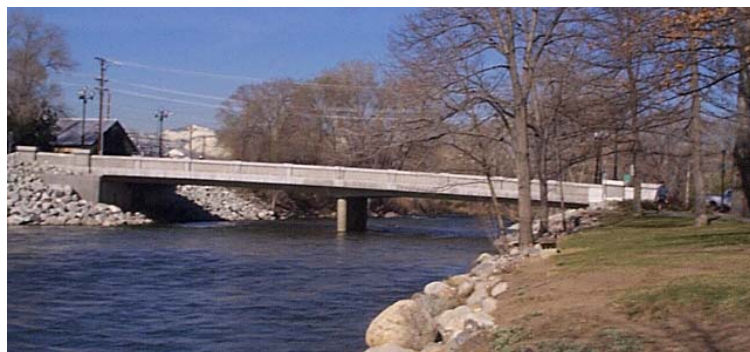
Photo 1

The Booth Street Bridge was built in 1994, replacing the previous structure that was constructed in 1920. The bridge, as shown in **Photo 1**, is approximately 128 feet in length and 54 feet in width. The bridge deck slopes from south to north at about 2.6%. The deck carries two-way traffic (one lane each way) and includes a pedestrian sidewalk on each side. The bridge was inspected and evaluated as part of the National Bridge Inventory in 2002. As shown in **Table 1**, Booth Street Bridge received a Sufficiency Rating of 96.7 with all items considered to be in good or very good condition.

Photo looking west at downstream face of Booth Street Bridge.

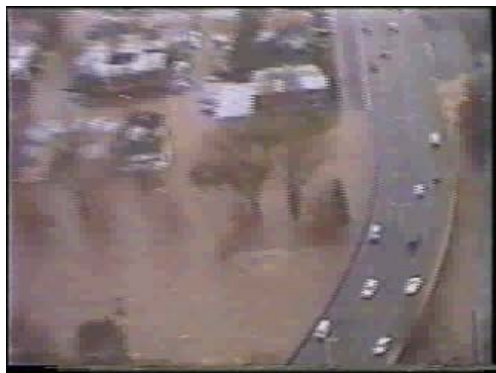
The Keystone Avenue Bridge, shown in **Photo 2**, was constructed in 1966. This structure is a four-span shallow arch bridge with piers and abutments supported by footings. The bridge is approximately 400 feet in length and 56 feet in width. The deck carries two-way traffic (two lanes each way) with no pedestrian sidewalks.

Photo 2
Photo looking north at Keystone Avenue Bridge during 1997 flood event.

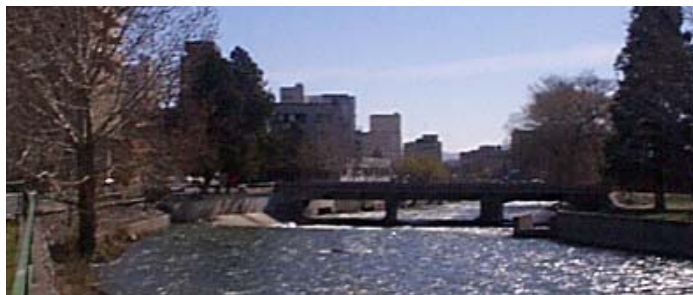
Photo 3

Photo looking east at upstream face of Arlington Avenue - North Bridge (Note photo taken prior to construction of Reno Whitewater Park).

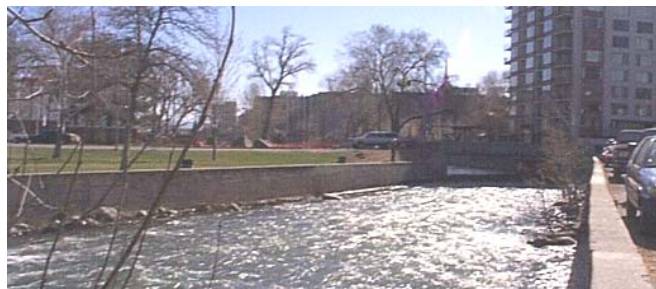
Photo 4

The South Arlington Avenue Bridge, shown in **Photo 4**, is a single span shallow arch bridge with abutments supported by footings. The deck carries two way traffic and two pedestrian sidewalks. The bridge is approximately 50 feet in length and 60 feet in width.

Photo looking east at upstream face of Arlington Avenue - South Bridge (Note photo taken prior to construction of Reno Whitewater Park).

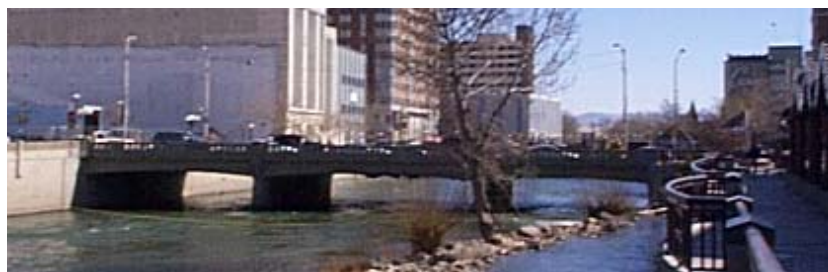
Photo 5

Photo looking east at upstream face of Sierra Street Bridge.

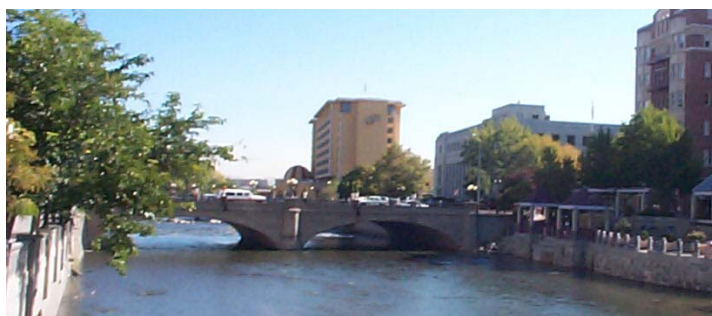
Photo 6

Photo looking east at upstream face of Virginia Street Bridge.

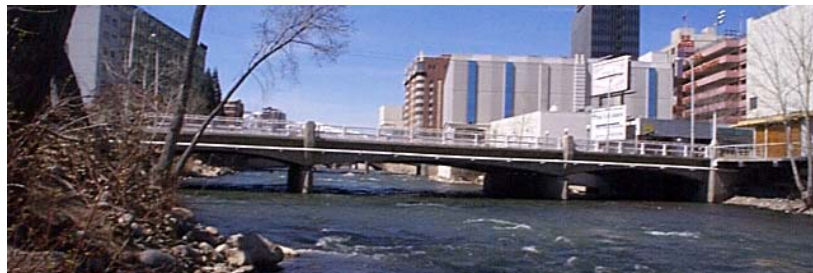
Photo 7

The existing Lake Street Bridge, as shown in **Photo 7**, is a three-span continuous concrete “tee beam” type bridge. The bridge was built in 1937. The deck is 176 feet long and 60 feet wide and is supported by “U” shaped abutments and two intermediate piers. The bottom chord of each span displays a parabolic curvature with a 2-foot 8-inch rise at mid-span. The deck carries two-way traffic (one lane each way) and has a parallel parking strip and pedestrian sidewalks on each side.

Photo looking west at downstream face of Lake Street Bridge.

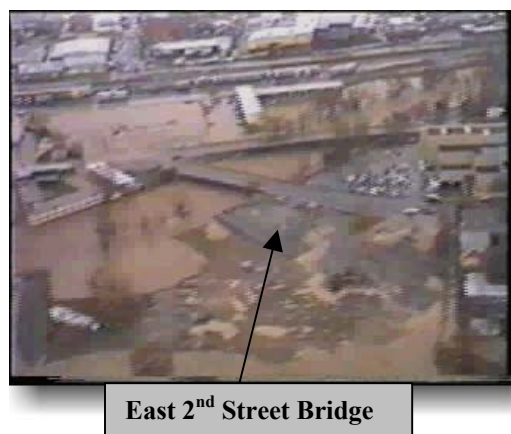
Photo 8

The existing 2nd Street Bridge consists of a concrete deck with steel underdeck and is supported by a single pier. The deck carries two way traffic (one lane each way) and has a parallel parking strip and a pedestrian sidewalk, as shown in **Photo 8**.

Photo looking north east at East 2nd Street Bridge and Kuenzli Avenue Bridge (downstream bridge).

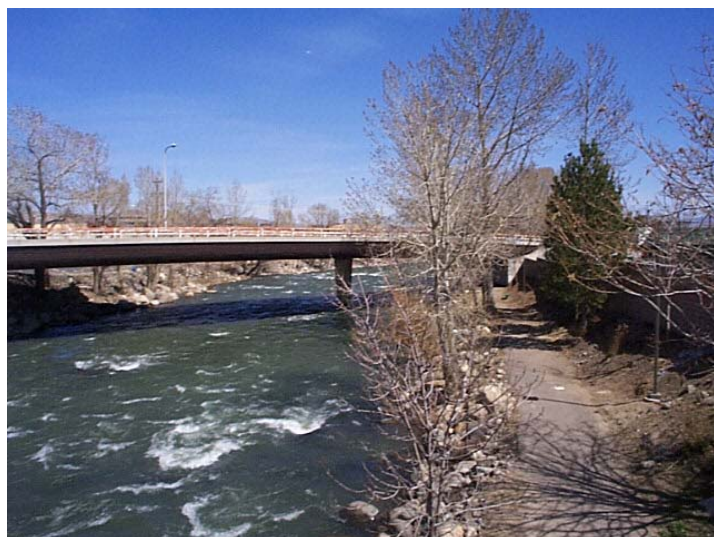
Photo 9

Photo looking east at upstream face of Kuenzli Avenue Bridge.

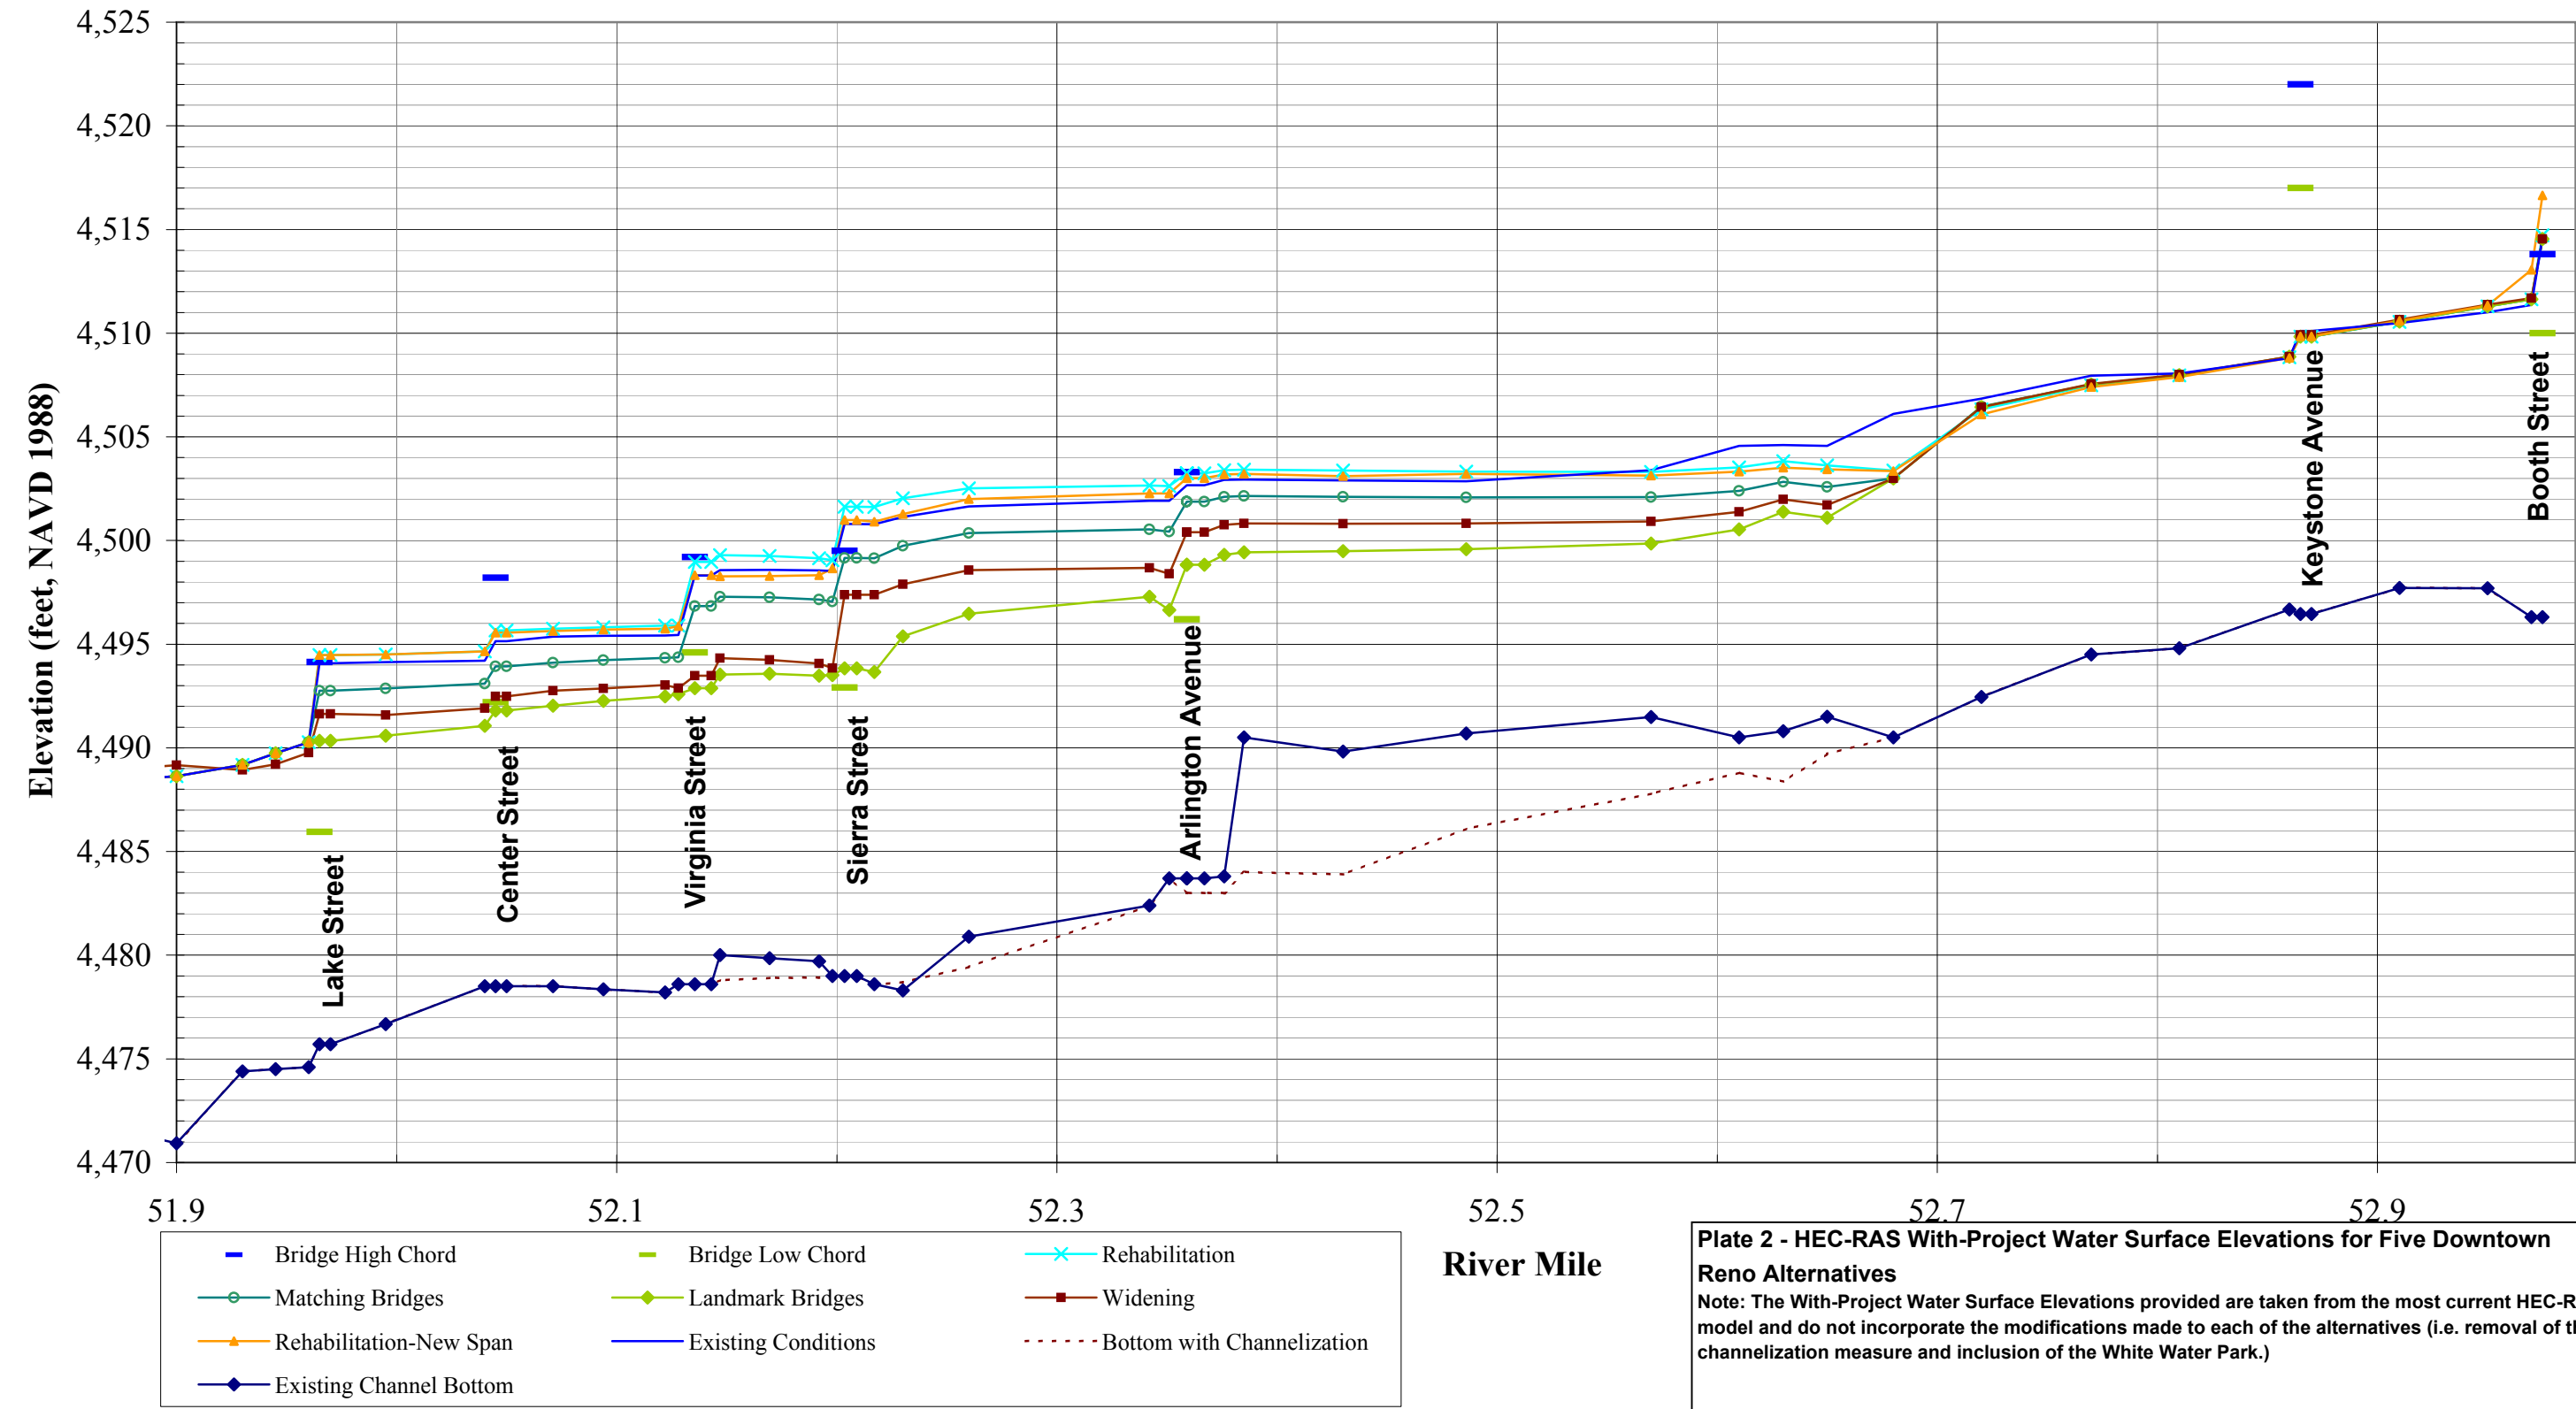
Alternative Profiles @ 20,700 cfs

The with-project water surface elevations were simulated with a HEC-RAS steady flow model. A discussion of the modeling process is included in the *Flood Damage Reduction Alternatives Report Addressing Downtown Reno Bridges*, 2002. The with-project water surface elevations presented in **Plate 2** include channelization (i.e. regrading of the river channel) between Keystone Avenue and Sierra Street. Due to the construction of the Downtown Reno Whitewater Park, channelization has been eliminated from each of the five alternatives. However, HEC-RAS simulation of the five alternatives including the new Whitewater Park and excluding the channelization have not been completed at this time.
